# **Debris/Ice/TPS Assessment and Integrated Photographic Analysis of Shuttle Mission STS-106**

**DEBRIS/ICE/TPS ASSESSMENT  
AND  
INTEGRATED PHOTOGRAPHIC ANALYSIS  
OF  
SHUTTLE MISSION STS-106**

**8 September 2000**

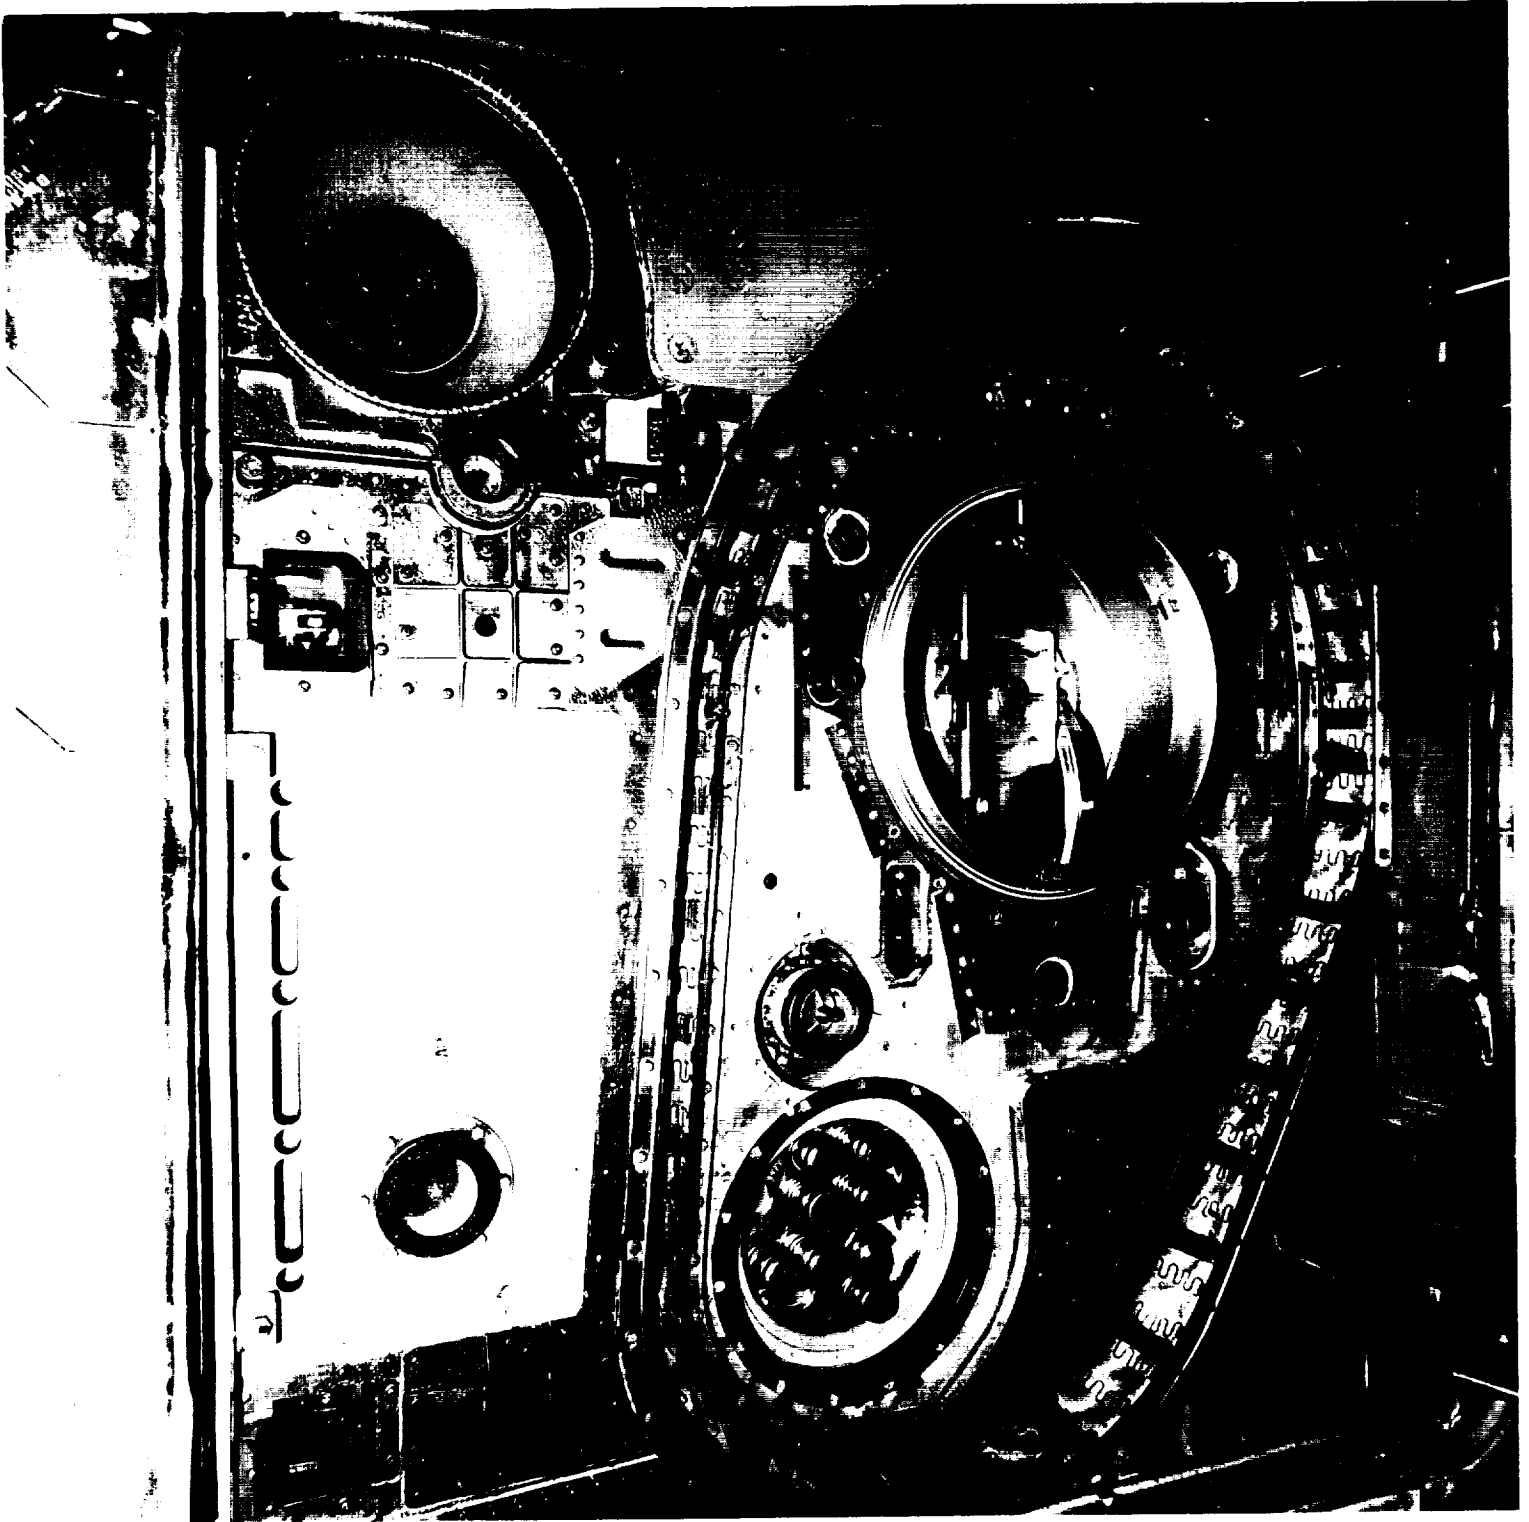
Photo 23: LO2 ET/ORB Umbilical

There were no TPS anomalies on the LO2 ET/ORB umbilical. Ice/frost accumulations were present on the aft and inboard sides. Ice/frost fingers on the separation bolt pyrotechnic canister purge vents were normal.

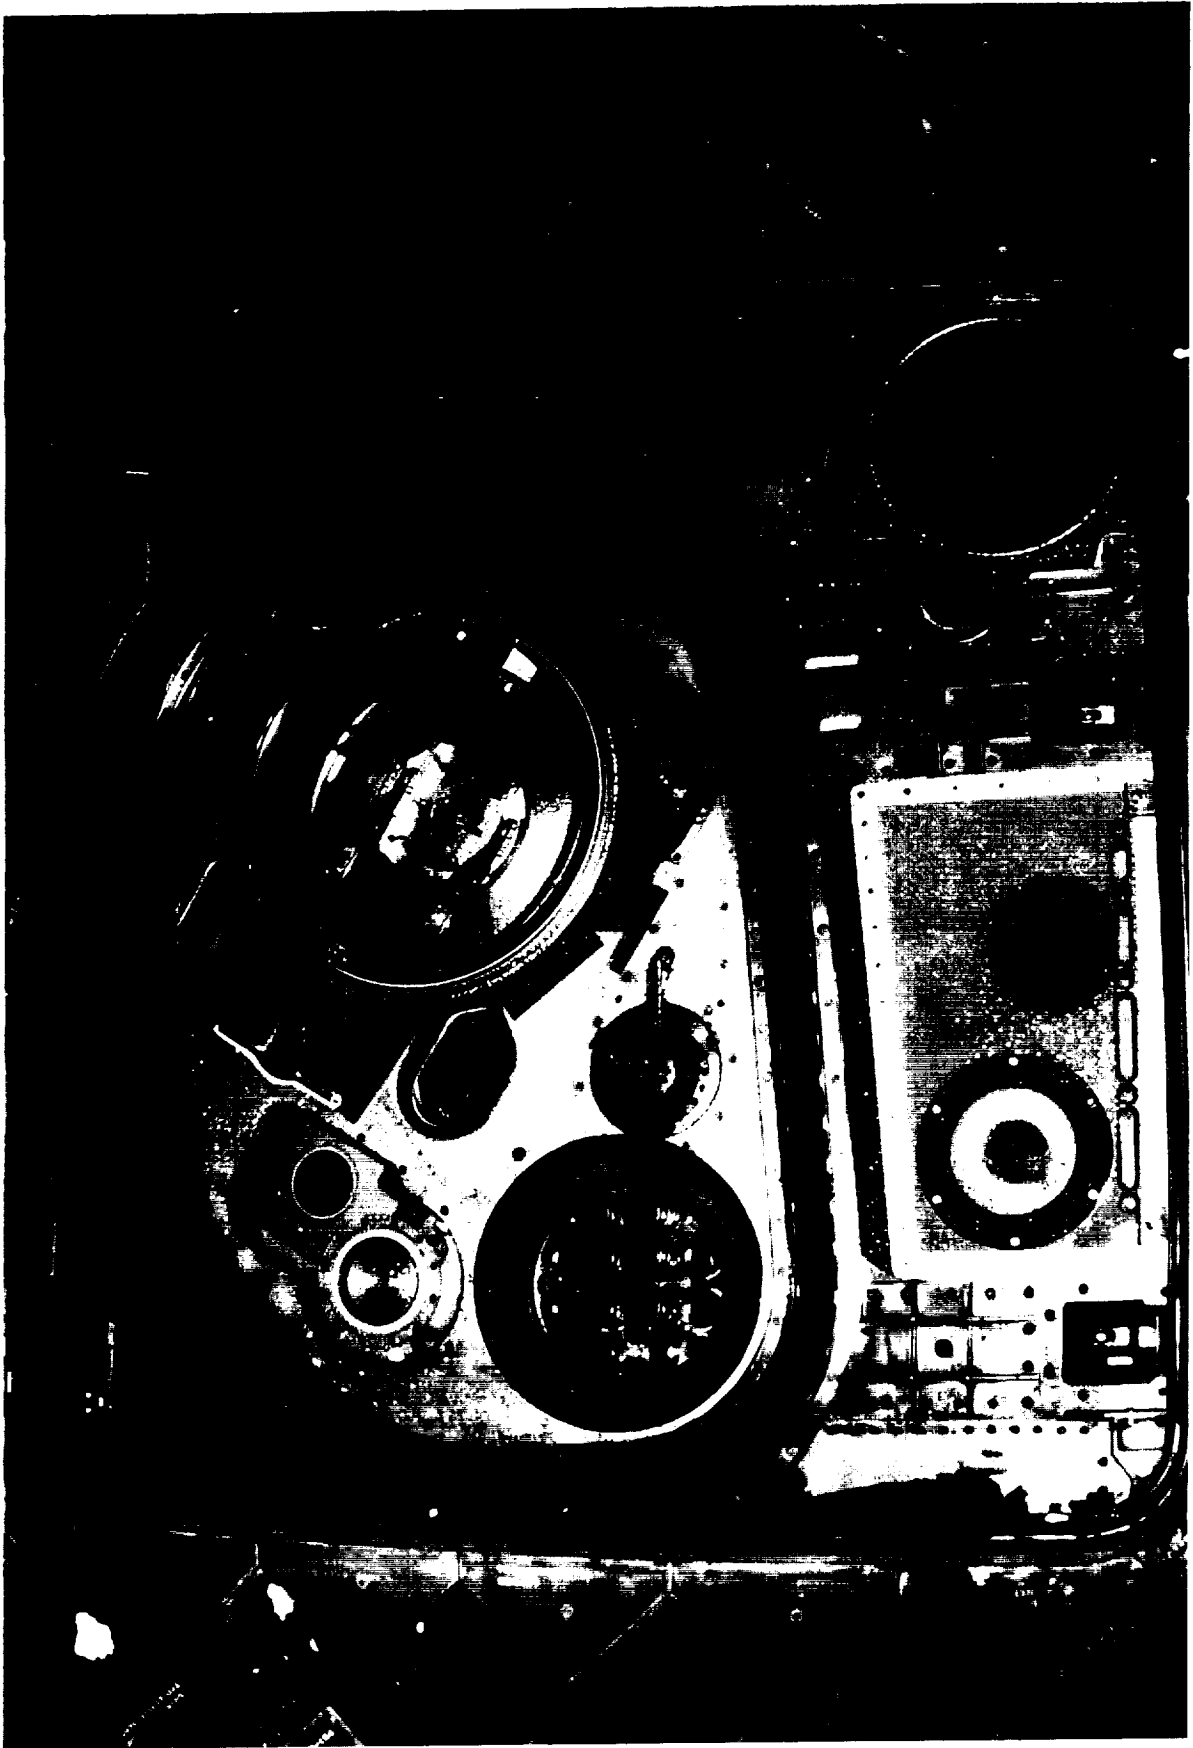
Photo 24: LH2 ET/ORB Umbilical

Ice and frost in the LH2 recirculation line bellows and on both burst disks was typical. Likewise, a normal amount of ice/frost had accumulated on the LH2 ET/ORB umbilical purge barrier outboard side, forward, and aft surfaces. Typical ice/frost fingers were present on the pyro canister and plate gap purge vents. No unusual vapors or cryogenic drips had appeared during tanking, stable replenish, and launch.

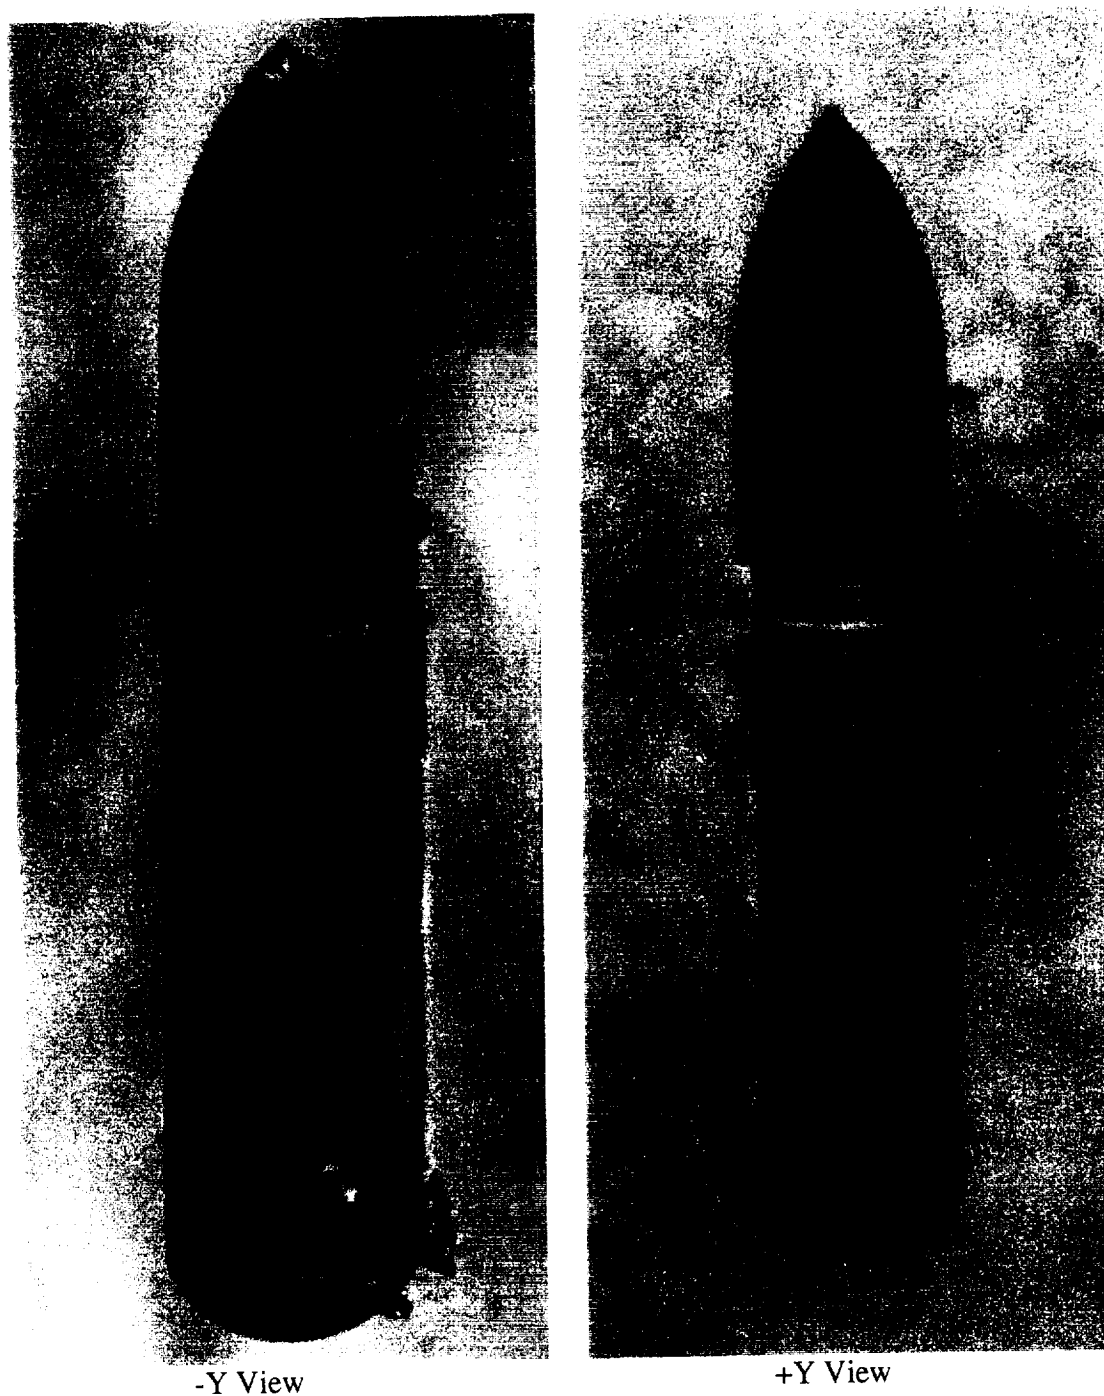
Figure 2.5.2 Handheld ET Views

No anomalous conditions were seen on the handheld imagery of the STS-106 External Tank (ET-103).

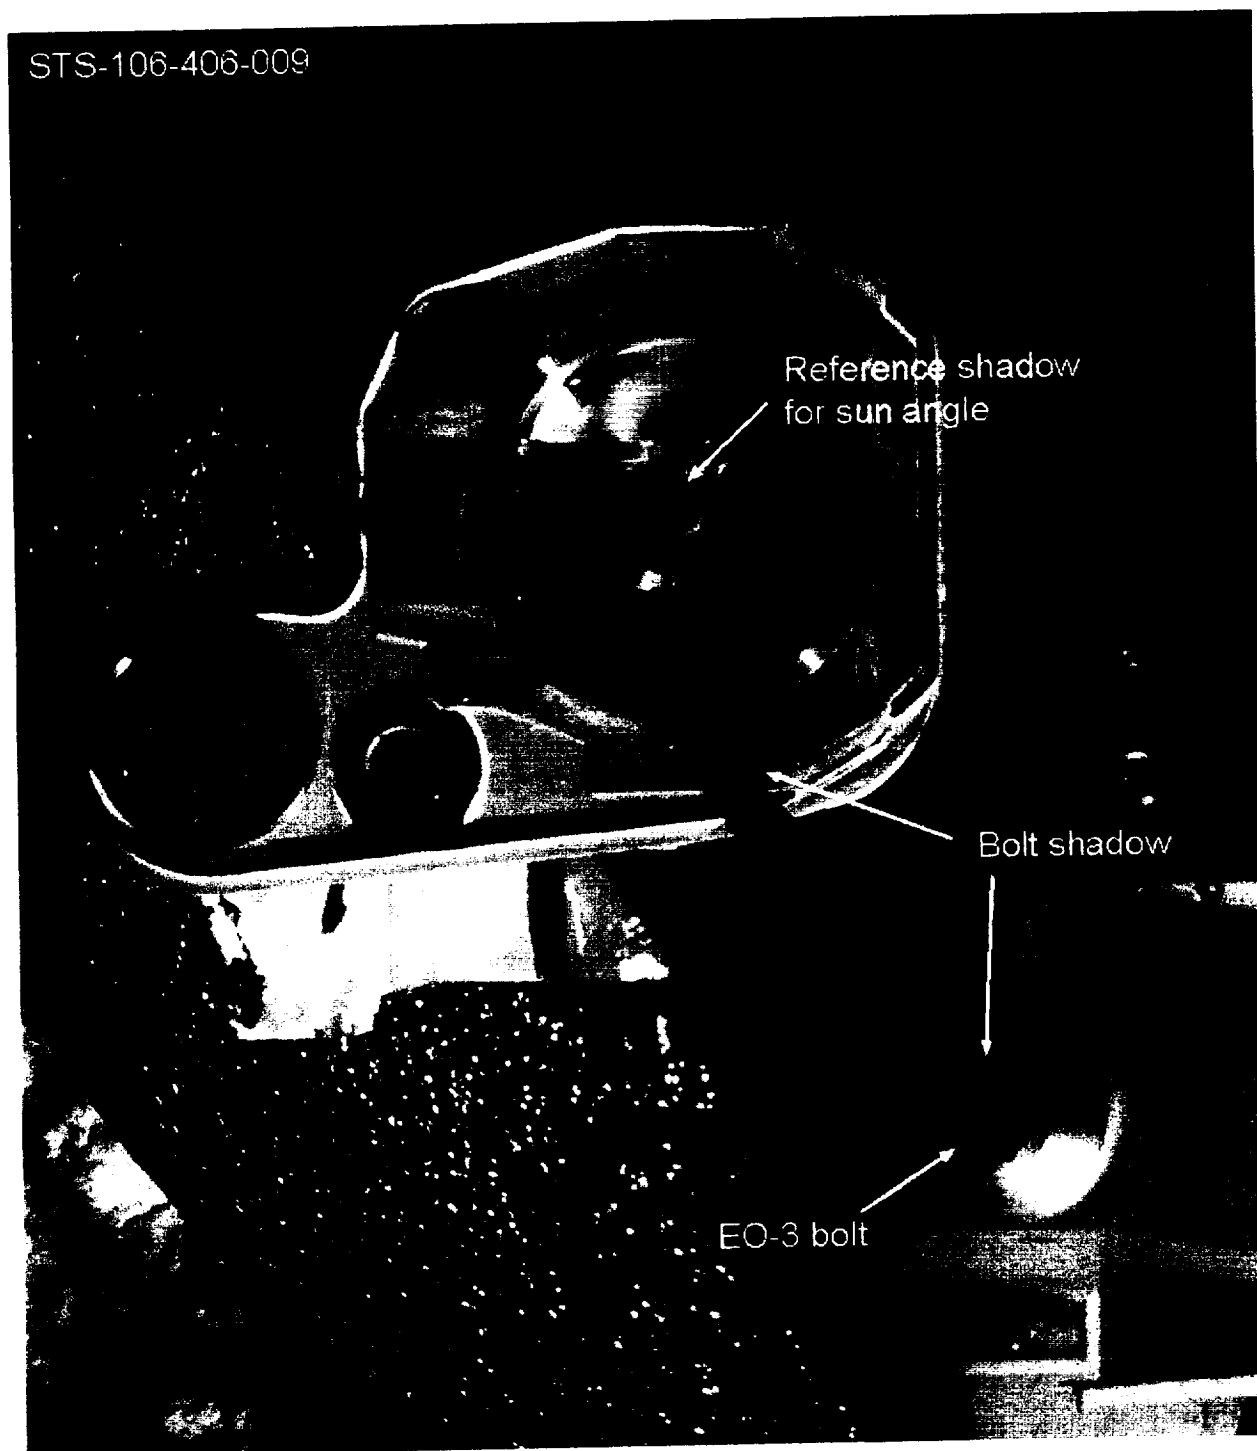
Figure 2.6.1 External Tank EO-3 Protruding Bolt

The unretracted EO-3 bolt seen on the 35mm ET umbilical well film was measured to be protruded 4.0 (+/- 0.25) inches above the plane of the attach fitting. See Figure 2.6.1.

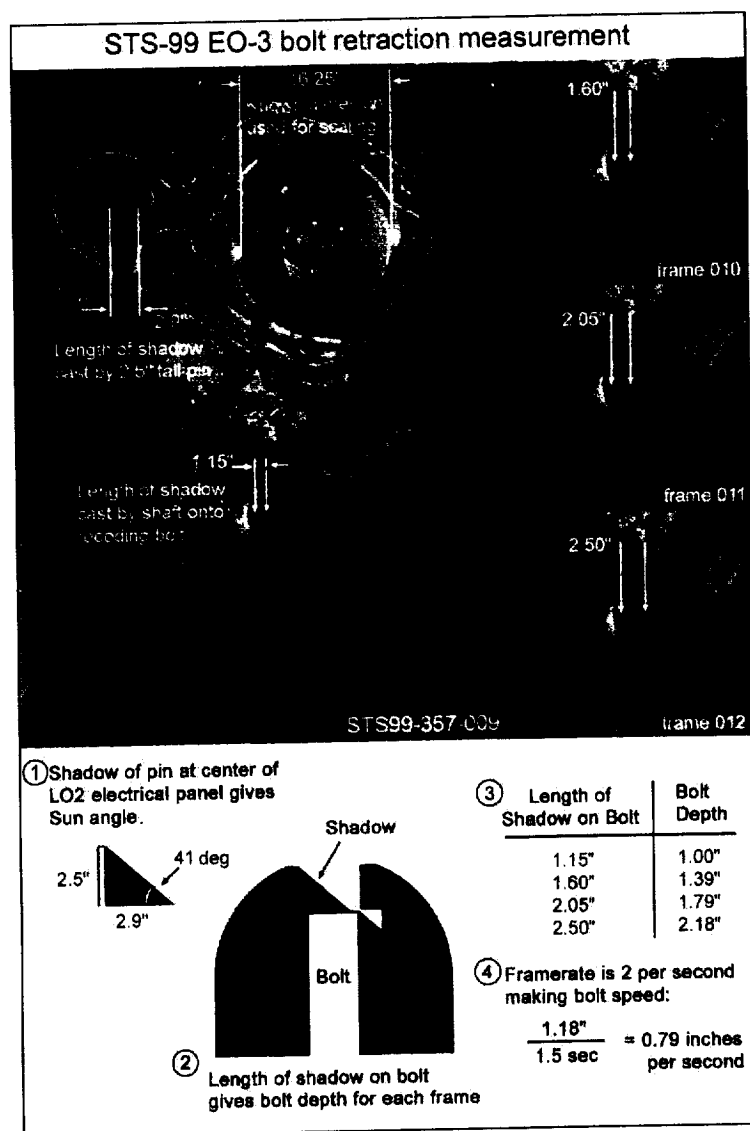
Figure 2.6.3 STS-99 EO-3 Bolt Retraction Analysis

A measurement of the rate of the retraction of the ET EO-3 bolt seen on the STS-99 35 mm umbilical film was requested in support of the investigation into the STS-106 extended bolt. The retraction rate of the STS-99 EO-3 bolt was measured to be 0.8 inches-per-second using four frames from the 35mm film ET umbilical well camera. Just after ET separation from the orbiter, the bolt was seen end-on as it receded into the attach fitting. (see Figure 2.6.3). The velocity of the bolt was measured using the length of the shadow cast by the bolt shaft across the end of the bolt as it retracted inward. Because the shadow cast by the bolt shaft across the end of the bolt was constant at 41 degrees (measured using the relative sun angle for those few frames was constant at 41 degrees (measured using the shadow cast by a 2.5-inch tall pin at the center of the LO2 electrical monoball) the length of the shadow on the bolt provided a measure of the depth of the bolt within the shaft over time. The velocity for the bolt during retraction was calculated using the camera frame rate of 2 frames-per-second.

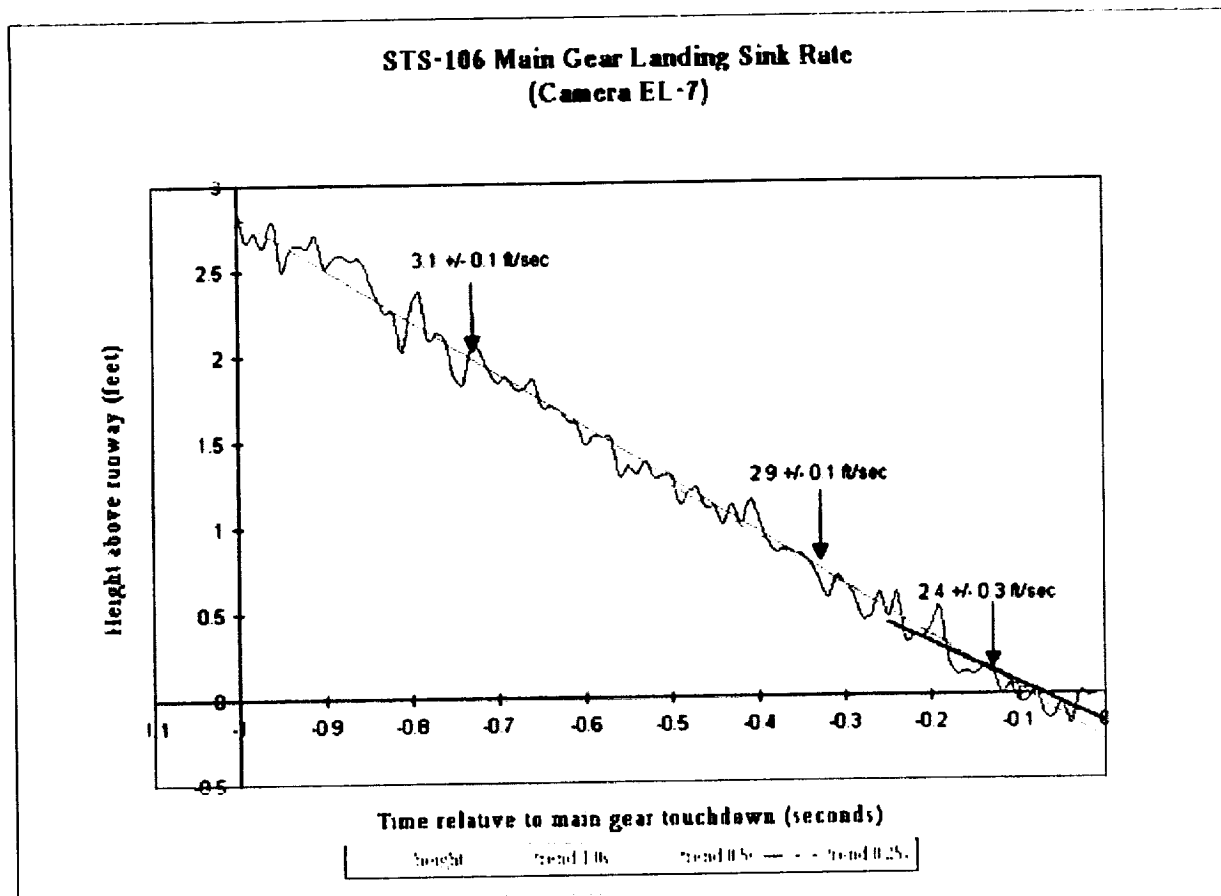
Figure 2.7 Main Gear Landing Sink Rate

The maximum allowable main gear sink rate values are 9.6 feet / second for a 212,000 lb. vehicle and 6.0 feet/second for a 240,000 lb. vehicle. The landing weight of the STS-106 vehicle was estimated to be 222,800 lbs.

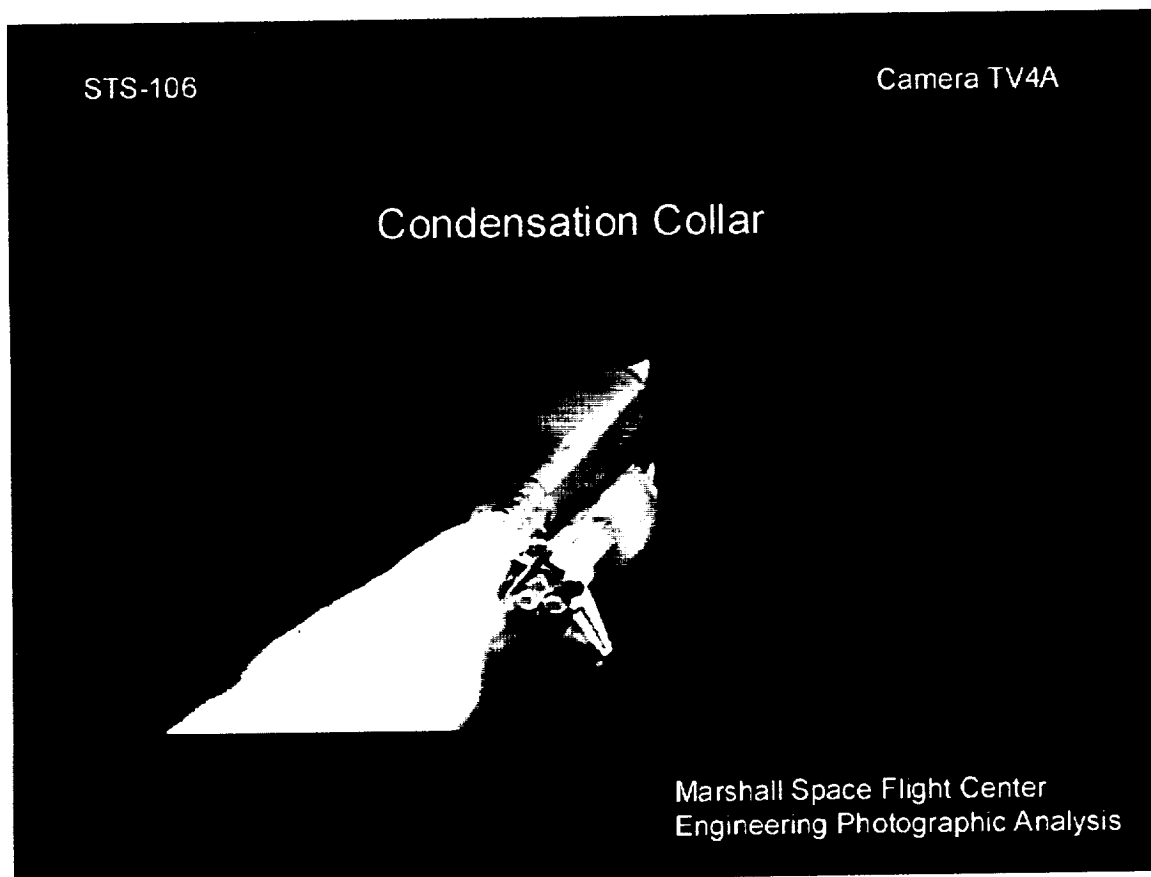
**Figure 1. TV-4A: Shock-induced Condensation Collar**

A "condensation collar" around vehicle was readily visible on this mission. This visible white cloud surrounding portions of the vehicle, the "condensation collar", is due to the change in atmospheric moisture condensing to liquid at the shock boundaries. Condensation collars around the vehicle have been noted on approximately 20 previous Space Shuttle missions.

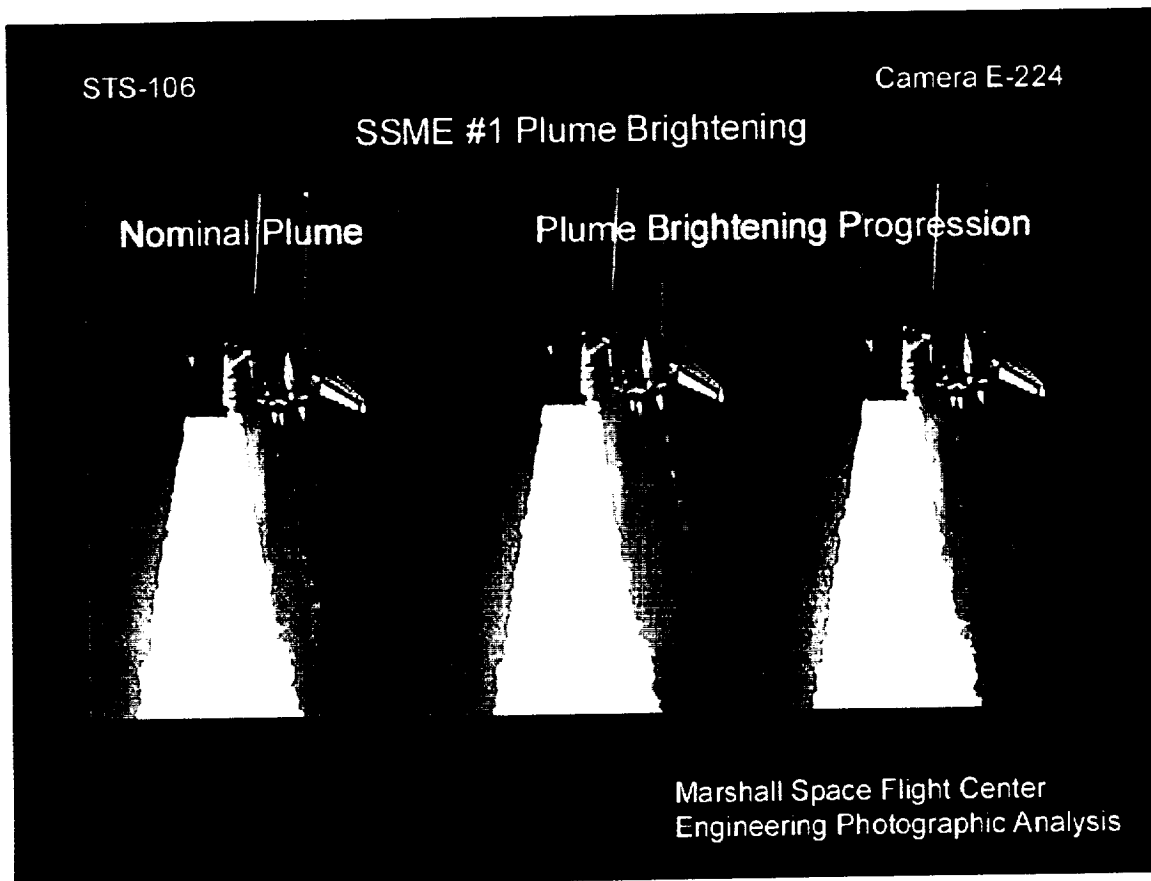
Figure 6. E-224: SSME Plume Brightening

Brightening of the SSME #1 plume was observed. The cause of this phenomenon is unknown but is thought to be related to engine streaking.

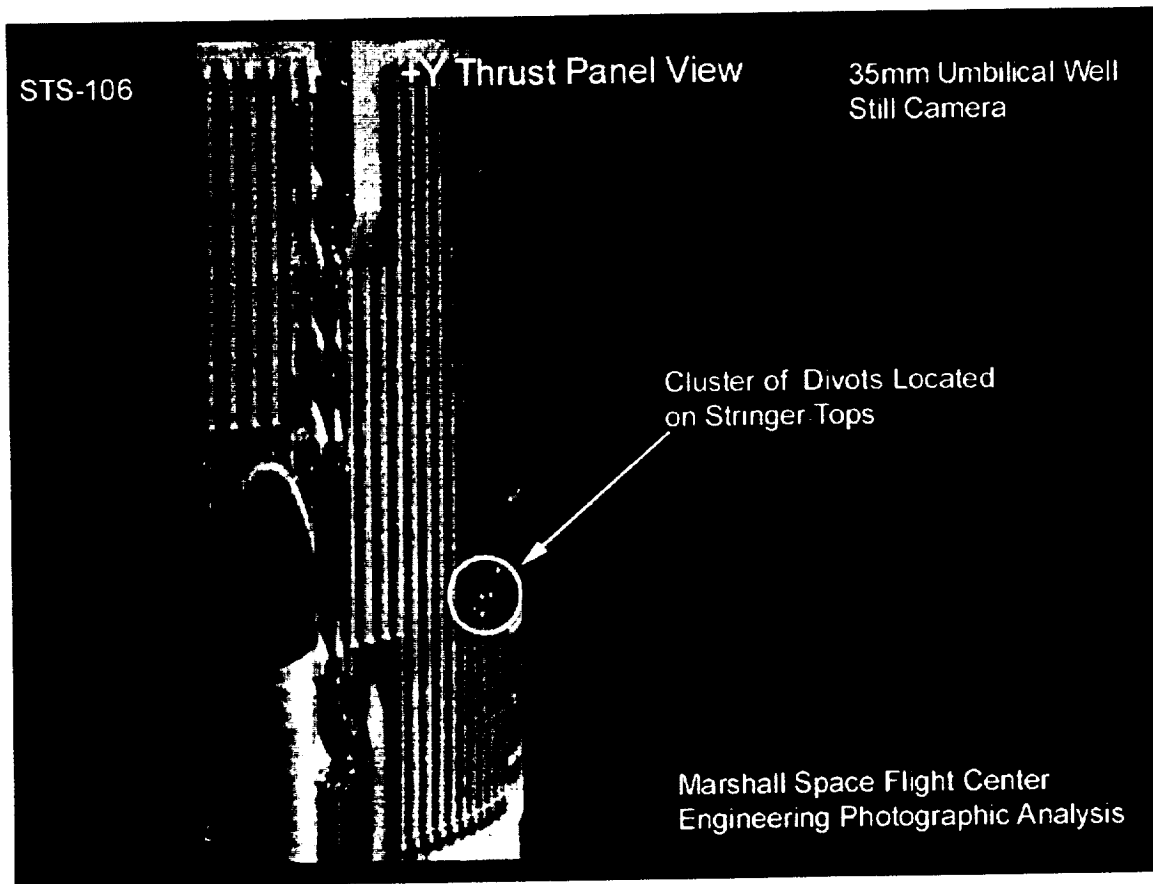
Figure 11. Divoting Observed near +Y Thrust Panel

Several divots were observed on the tops of stringers between the LO2 Feedline and the +Y Thrust Panel, including a cluster of five divots noted in the figure.

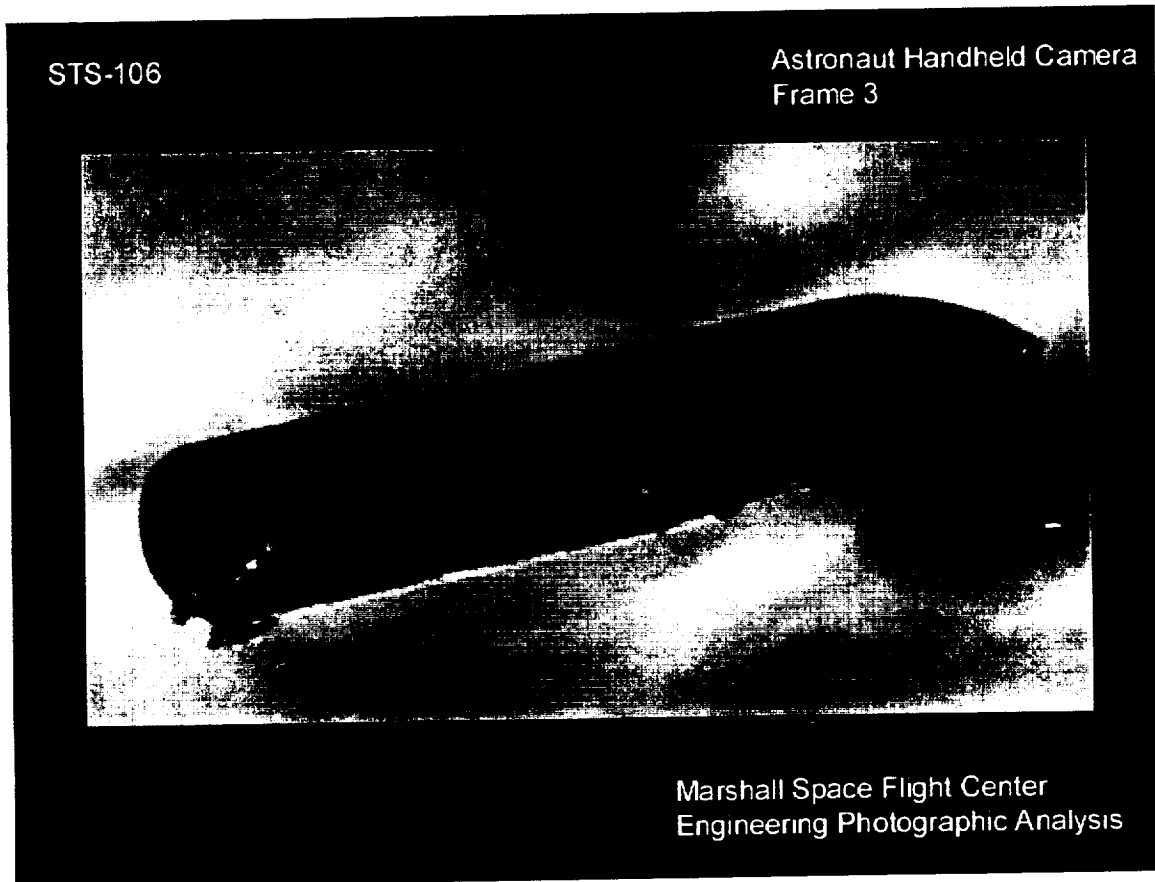
**Figure 12. Astronaut Handheld Camera View of -Y Side of ET**

Normal SRB separation burn scars on the intertank and aeroheating marks on the nose TPS were noted on the -Y side of the ET. Divoting was hard to discern at the resolution of these pictures, but was visible in the Umbilical Well imagery. Possible divoting of the LH2 to Intertank Interface in the -Y (left) direction from the bipod is indicated.

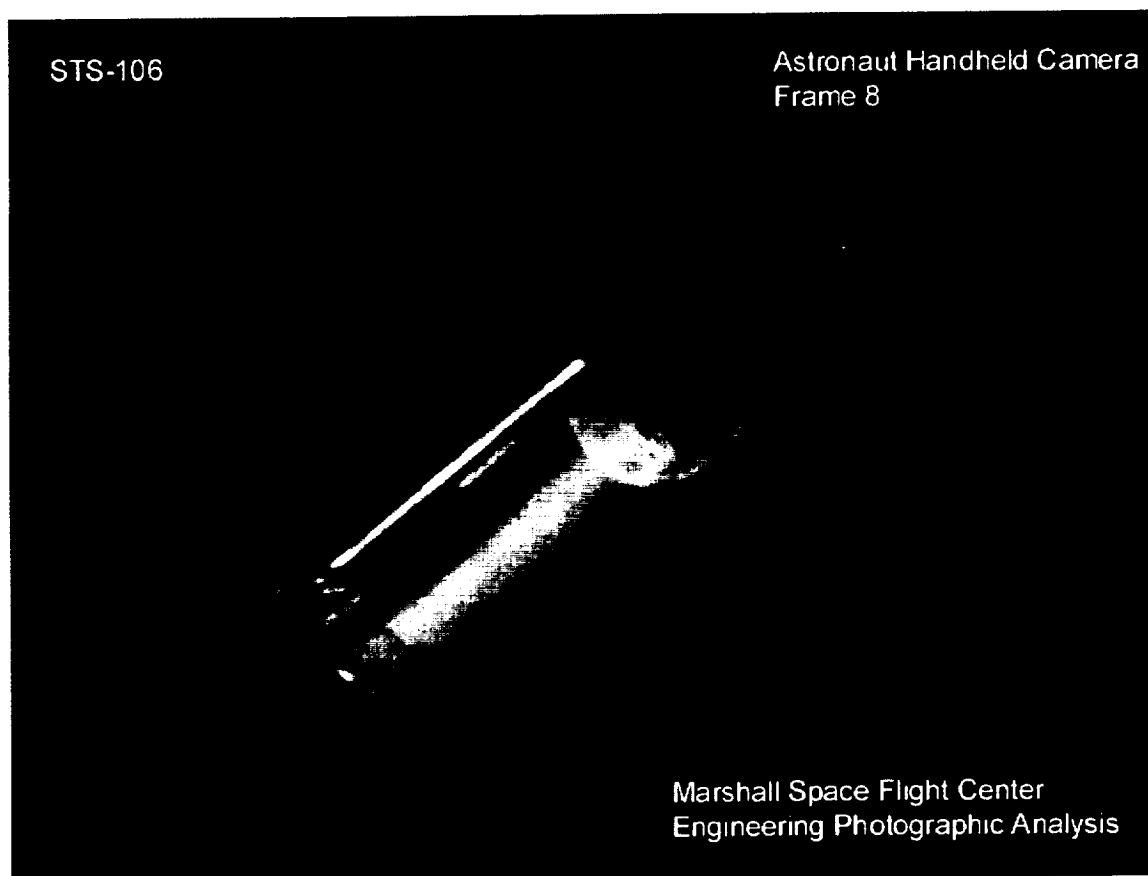
**Figure 13. Astronaut Handheld Camera View of +Y Side of ET**

Normal SRB separation burn scars on the intertank and aeroheating marks on the nose TPS were noted on the +Y side of the ET. Divoting was hard to discern at the resolution of these pictures.

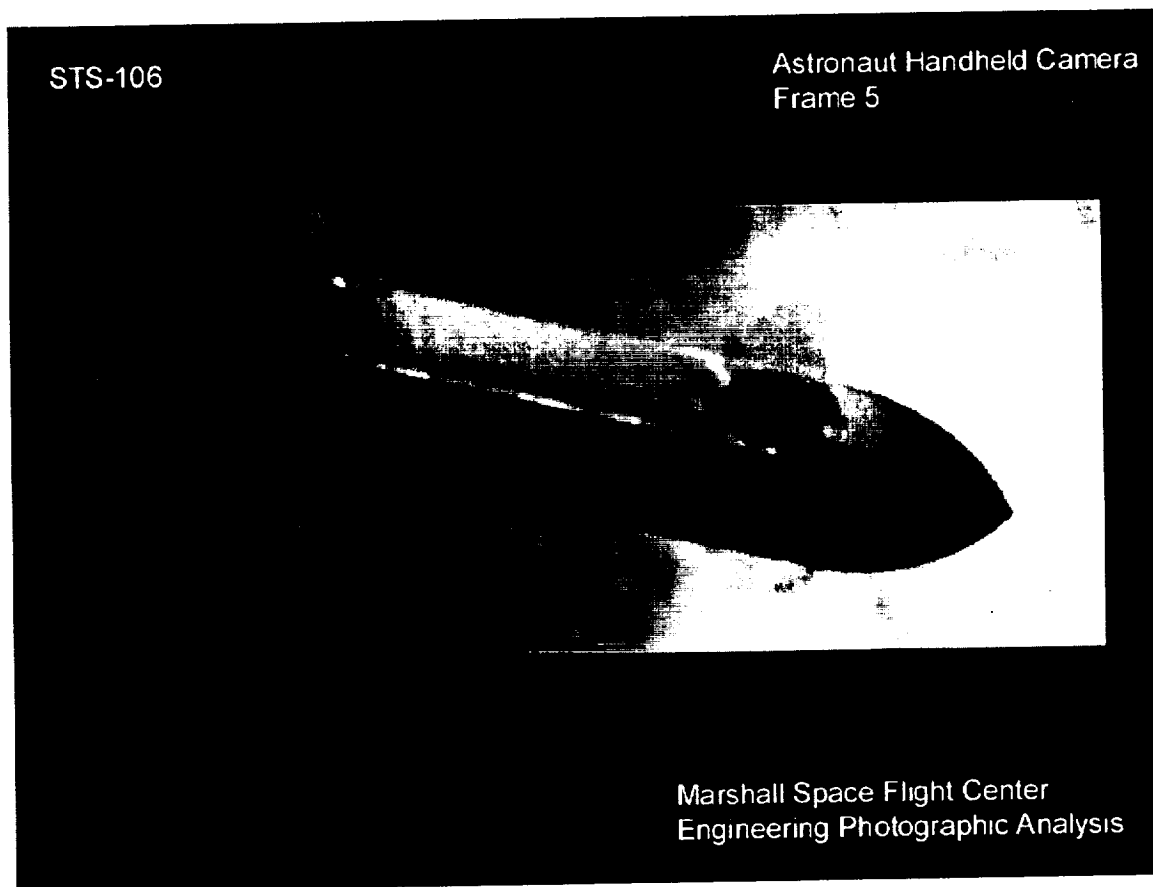
Figure 14. Astronaut Handheld Camera View of Aft and +Z Side of ET

Normal charring of the aft dome TPS was noted on the ET. Divoting was hard to discern at the resolution of these pictures. The ET +Z side appears normal.
